Docket No. 217 – Development and Management Plan Inspection

Northeast Utilities Service Company Certificate of Environmental Compatibility and Public Need for the construction of a 345-kV electric transmission line and reconstruction of an existing 115-kV electric transmission line between Connecticut Light and Power Company's Plumtree Substation in Bethel, through the towns of Redding, Weston, and Wilton, and to the Norwalk Substation in Norwalk, Connecticut.

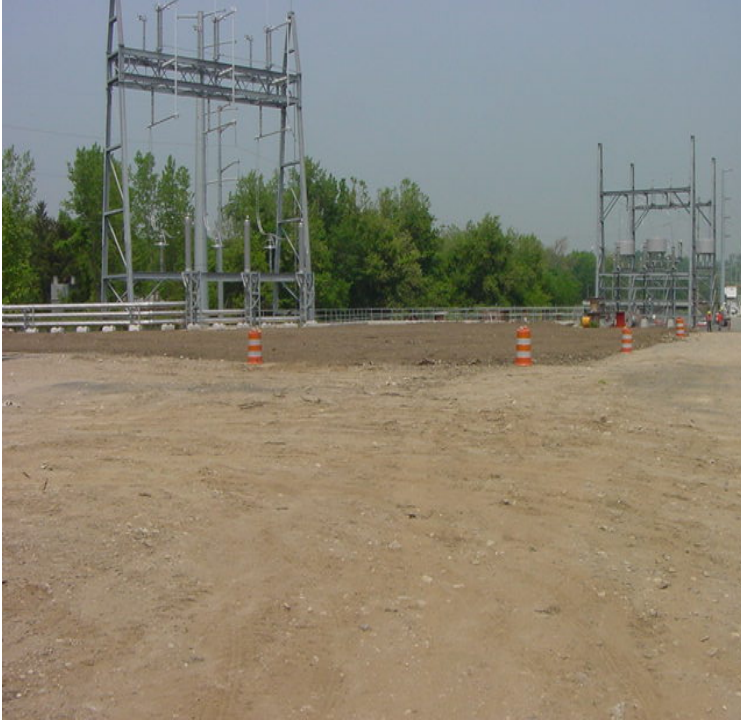
Norwalk Substation: Photo on the left shows where topsoil is spread and landscaping is occurring. Photo on the right shows the current status of the overflow channel. Vegetation is growing well with few bare spots remaining. 6/1/06.

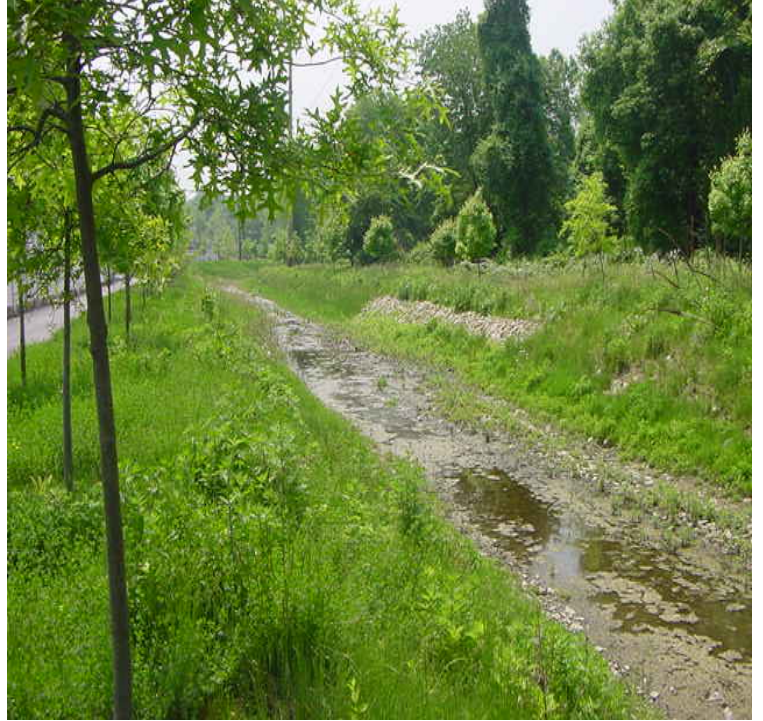
Inland Wetland and Watercourse encroachment and mitigation	- The overflow channel had moderate flow conditions. 6/1/06. - Vegetation continues to grow well along the	-None at this time. 6/1/06 - None at this time. 6/1/06.	-N/A -N/A.

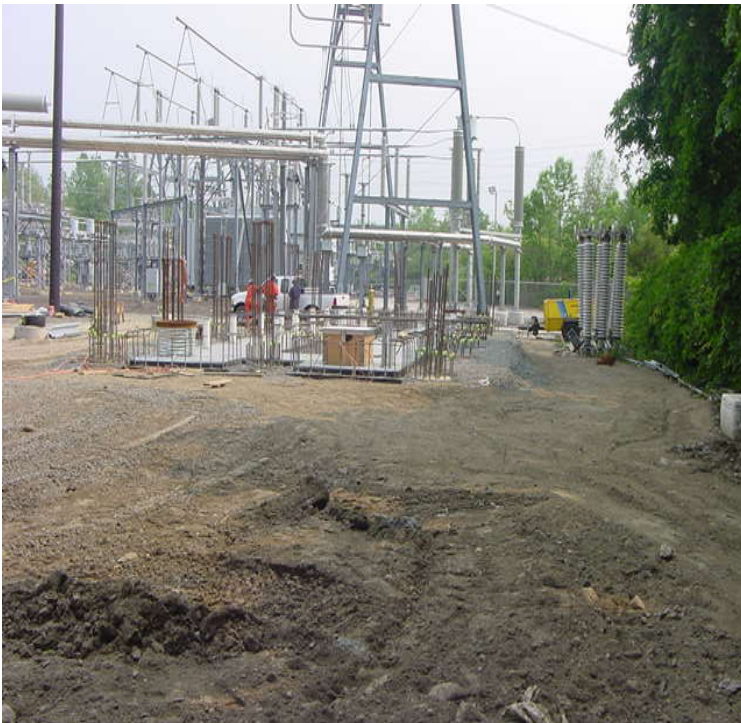
Plumtree Substation: Photo on the left shows the newly installed slab at the rear of the site. Photo on the right shows work on an adjacent steel structure. 6/1/06.
